# Turning the Swan River Right-Side Up

October 9, 2019

Troy Thompson, Ecological Resource Consultants, Inc.  
Jason Lederer, Summit County Open Space and Trails

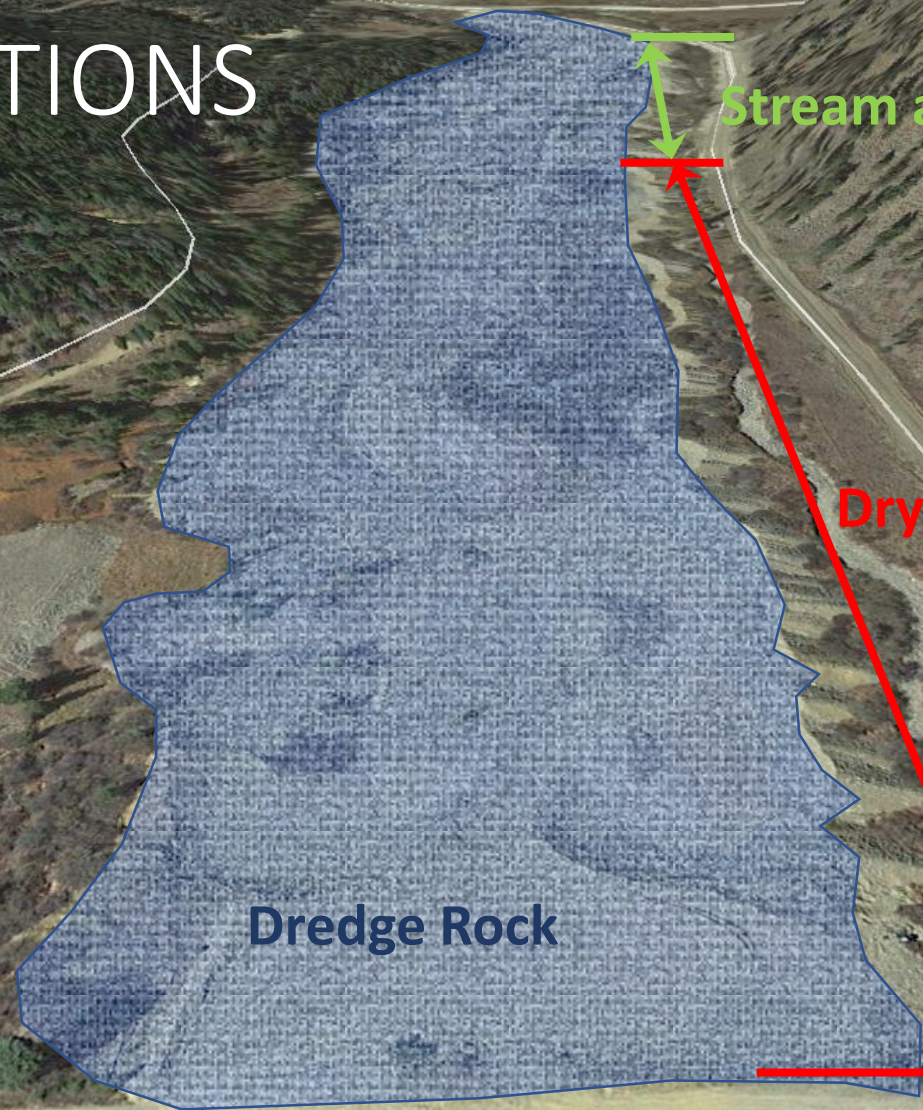
# SITE CONDITIONS

Stream at Surface

Dry stream channel

Dredge Rock

Rock Island Rd

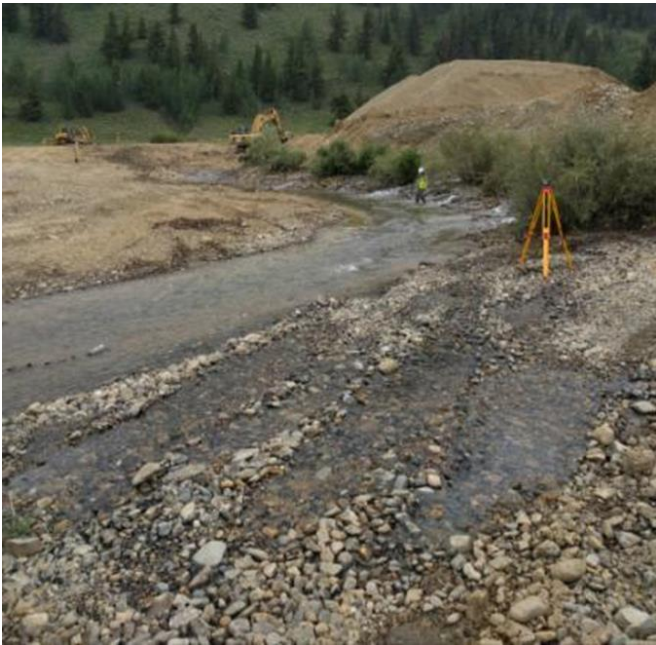
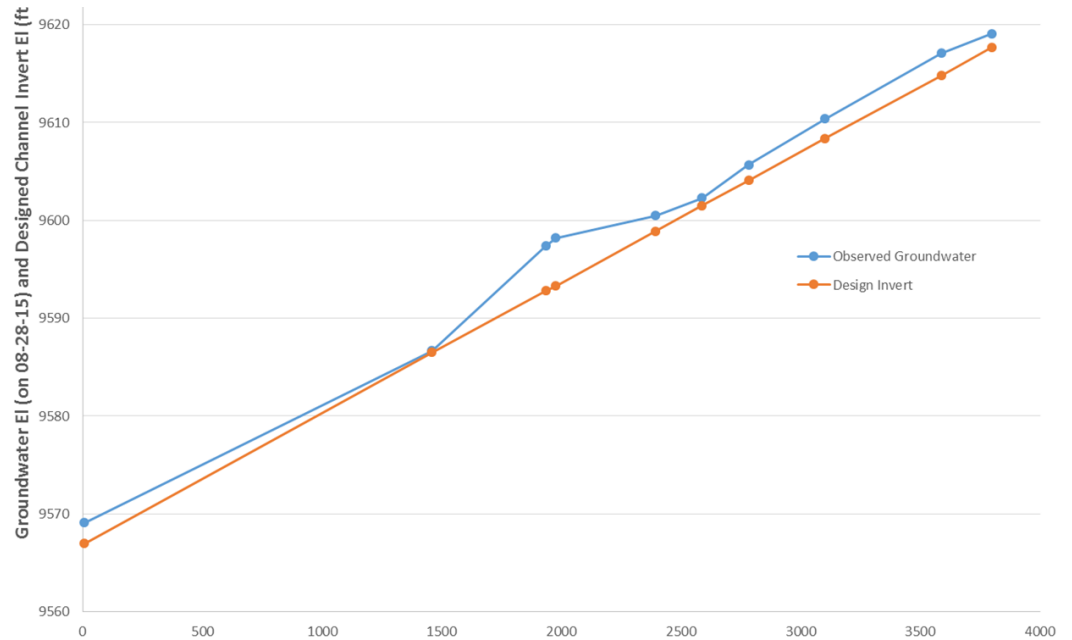
Historical Piezometer Readings in Swan River Valley

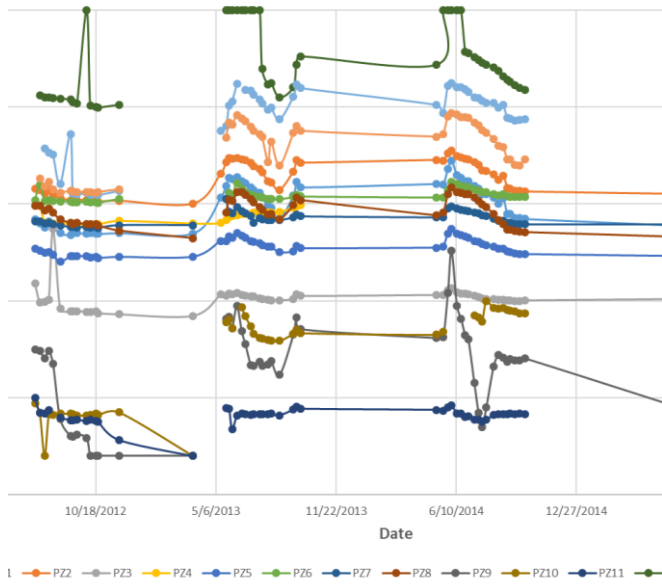
Understand Groundwater Levels to Achieve Gaining Stream

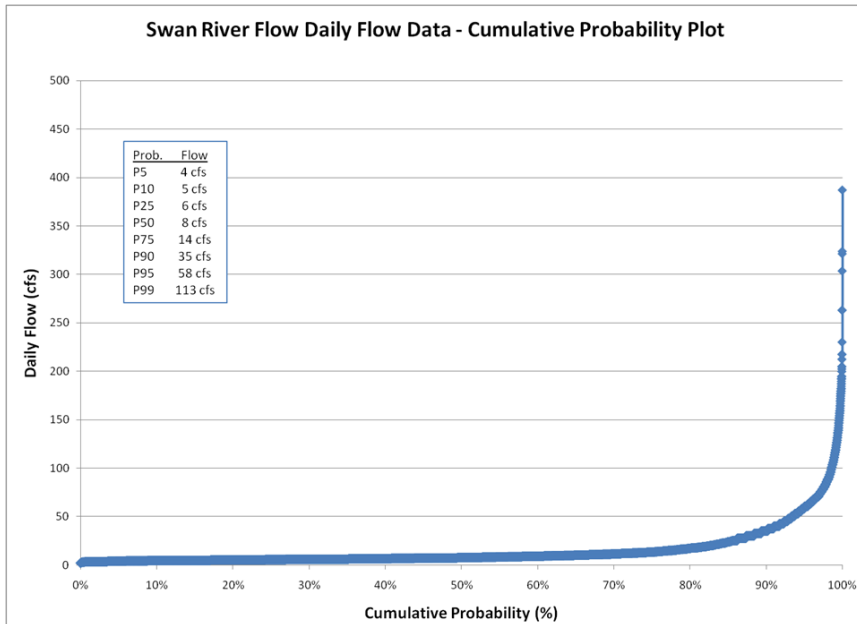
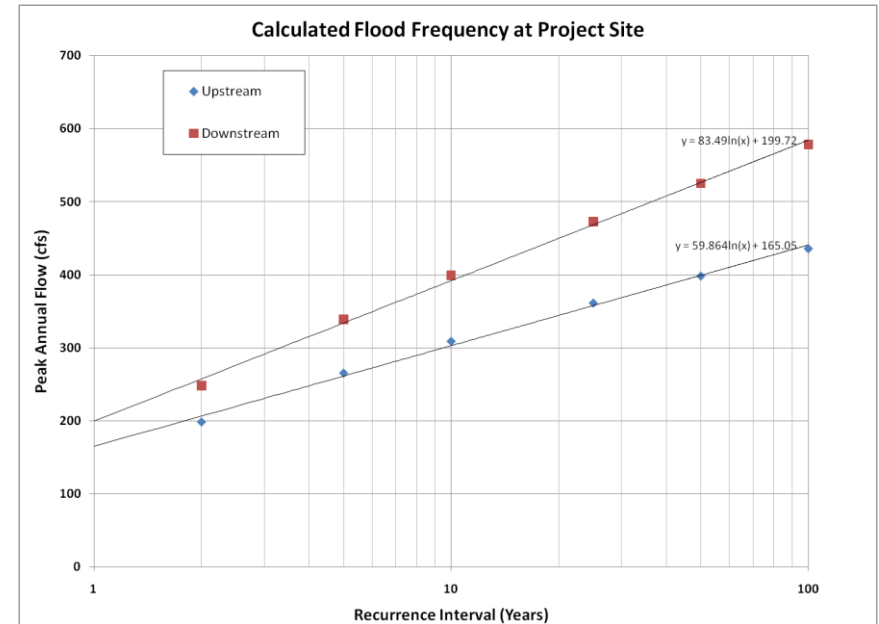
# Define Flows for Subsurface Stream Bankfull Discharge (~230 cfs) & Flow Frequency

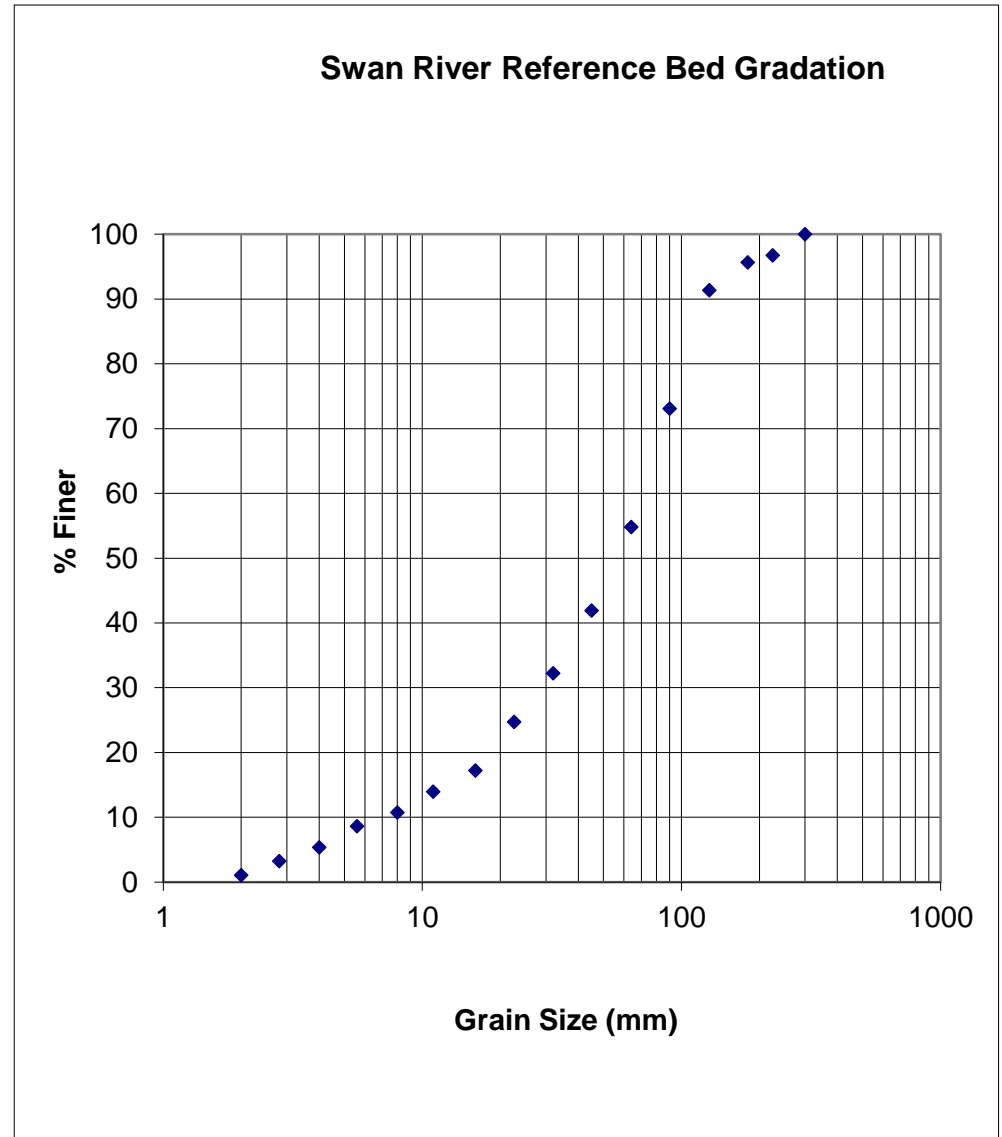
Design a Natural, Low Permeability Liner that Could be Manufactured from On-Site Materials

- Didn't want to use a synthetic liner
  - Cost
  - Natural system
  - Promote surface/GW interaction
- Used Fuller-Thompson method and sediment sampling in reference section to define gradations for a natural, low permeability liner

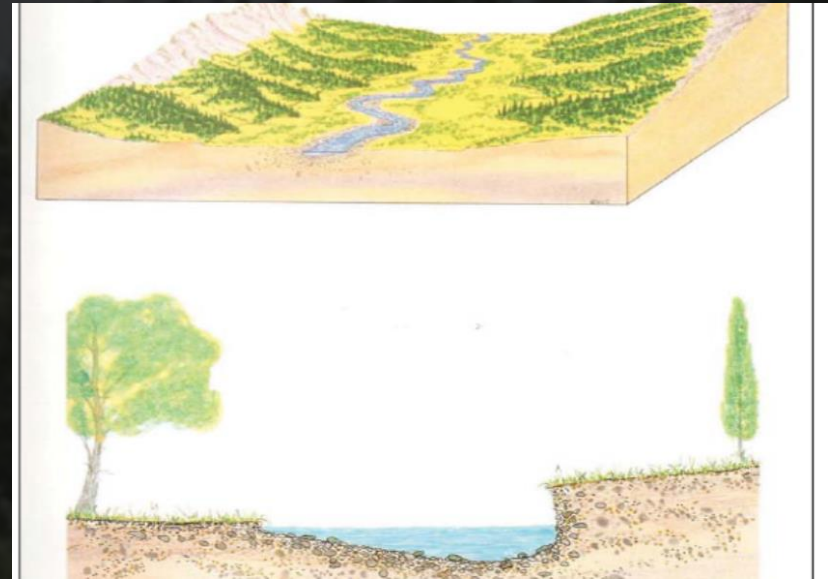
# Obtain Floodplain Connectivity

- Have flows access its riparian floodplain above bankfull
- Entrenchment ratio  $> 3$
- Mimic a natural Montgomery-Buffington Pool/Riffle and Rosgen Type C stream

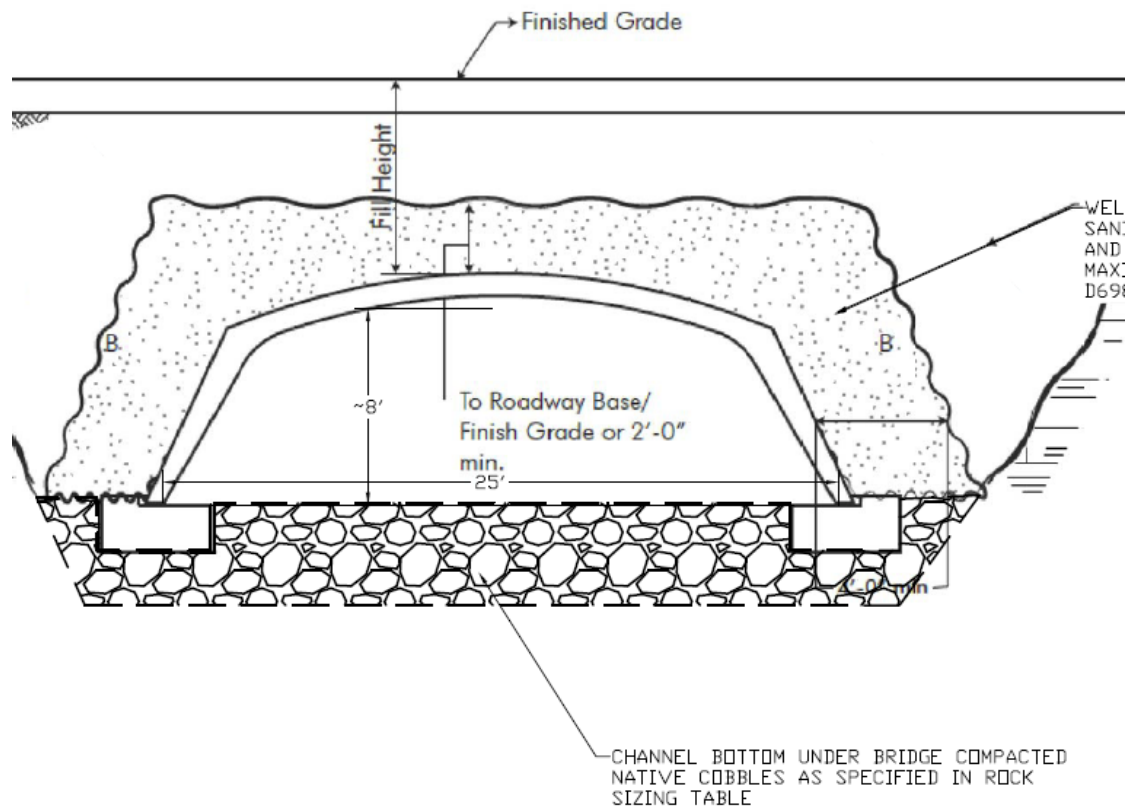
- Remove existing 8 foot vertical barrier created by Tiger Road
- Bridge width exceeds bankfull channel width
- Passes 100-year flood with ~ 3 feet of freeboard
- Natural bottom promotes passage of aquatic organisms

Design Cost Effective Bridge at Tiger Road that Meets Project's Ecological Objectives

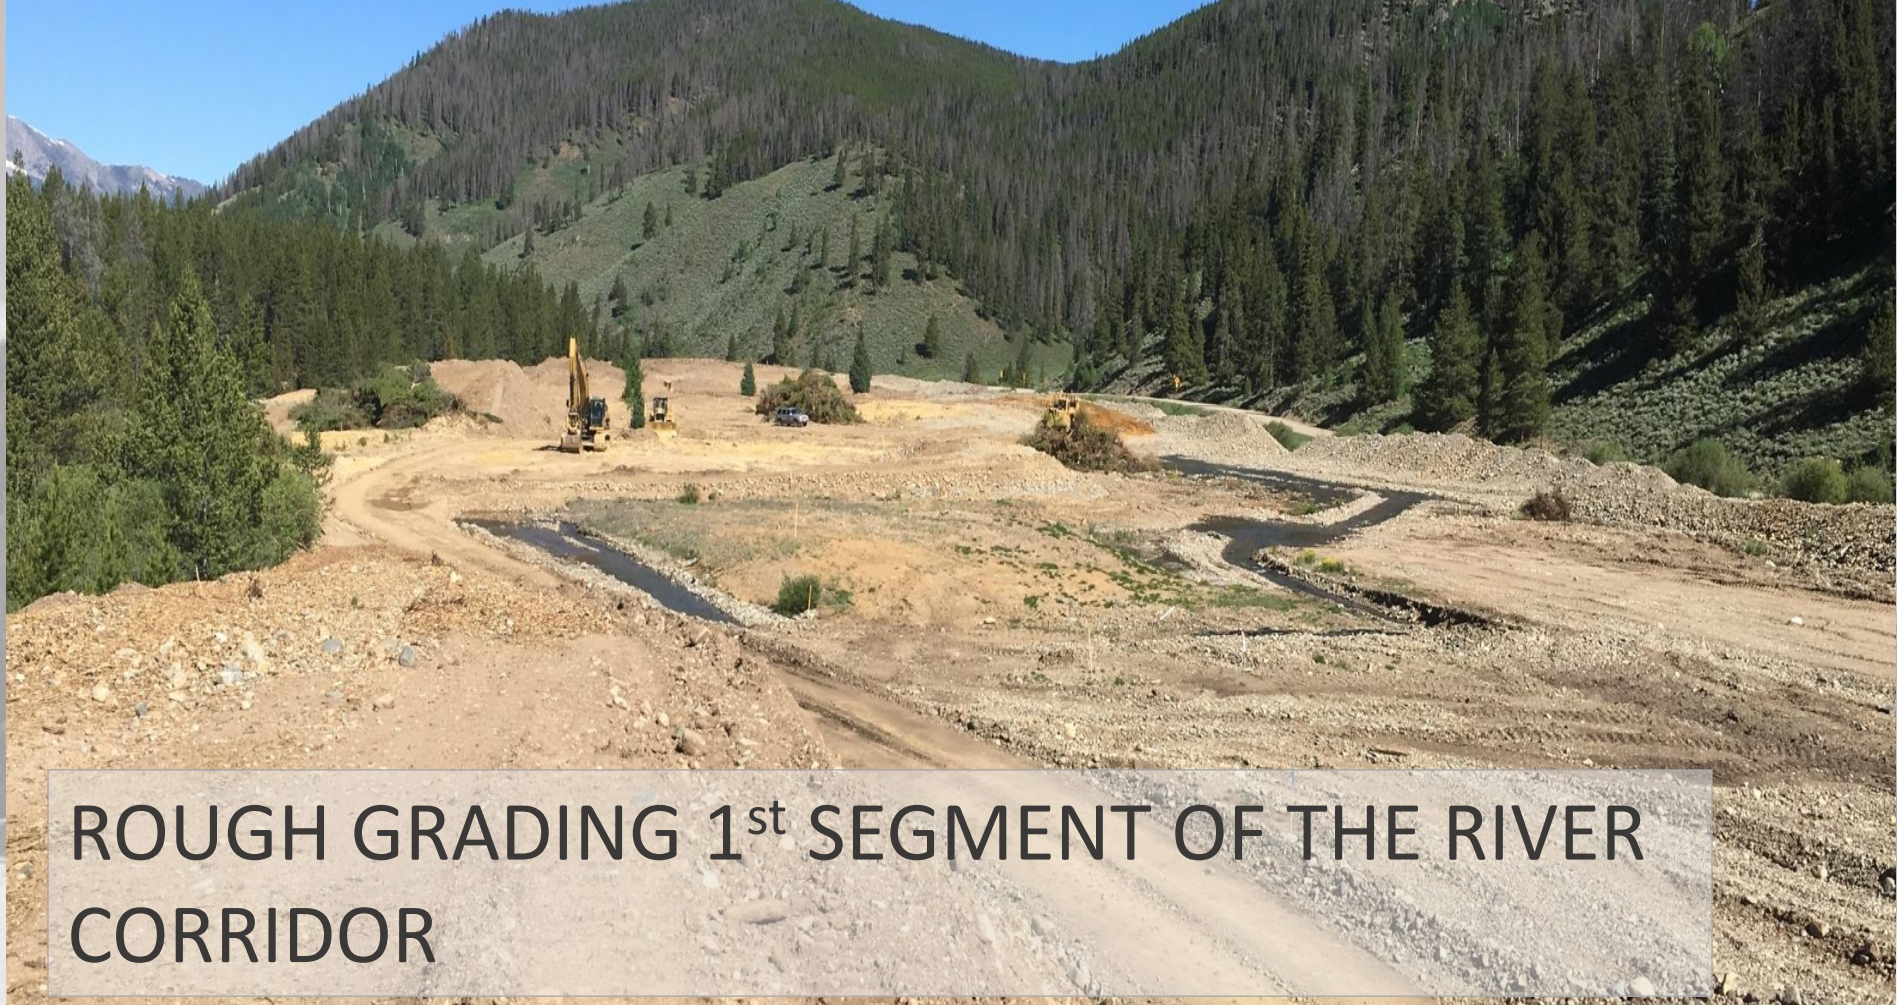
# ROUGH GRADING 1<sup>st</sup> SEGMENT OF THE RIVER CORRIDOR

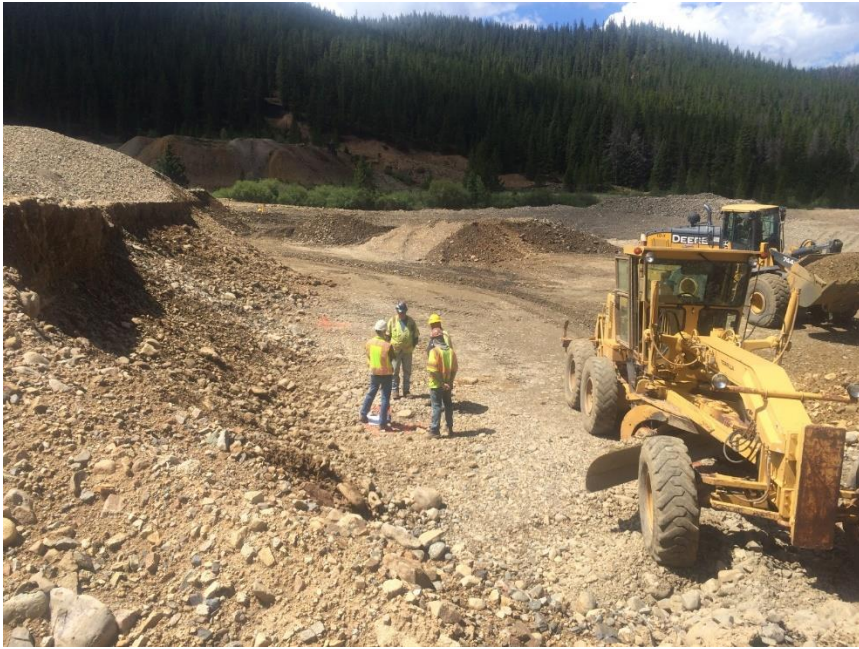
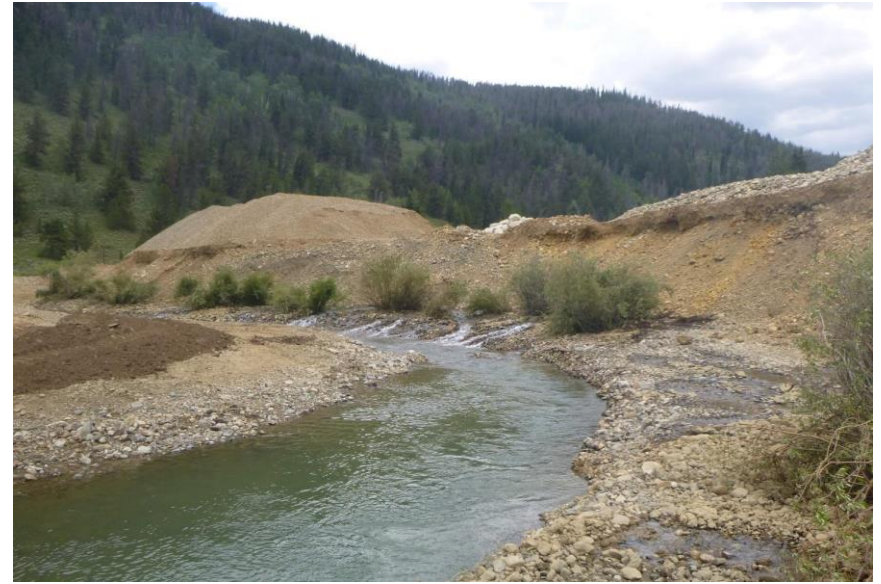
## BEFORE AND AFTER INITIAL CHANNEL EXCAVATION

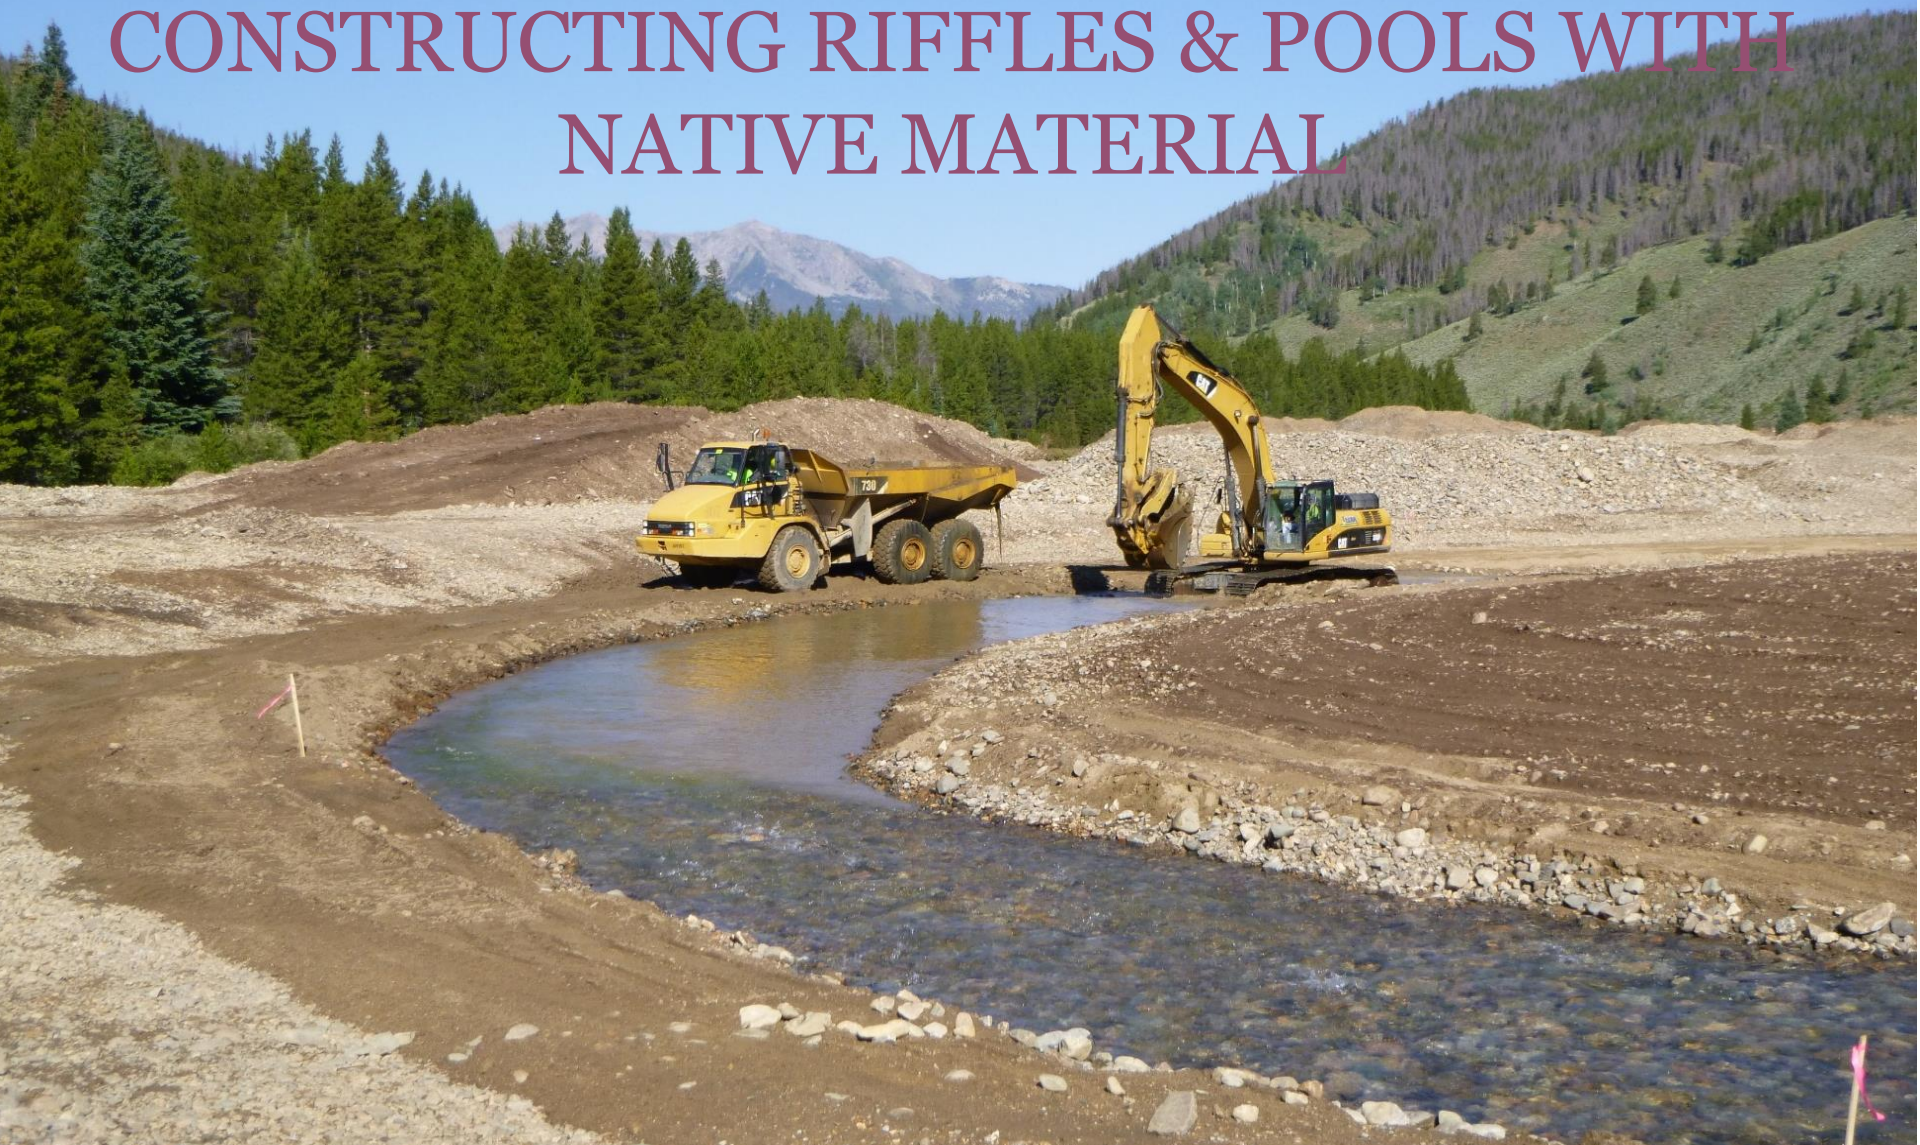
# CONSTRUCTING RIFFLES & POOLS WITH NATIVE MATERIAL

- Materials Generated On-Site
- Larger Cobbles (6" +)
  - Grade control
  - Bank stabilization
  - Riffle heads
- Smaller Cobbles (3" – 6")
  - Riffles
  - Banks
- Gravels (3/4" – 3")
  - Pools and glides
  - Non-critical banks
  - Random fill
- Finer Material (<3/4")
  - Channel liner
  - Matrix for create planting soil
- Use of on-site material resulted in huge cost savings and makes sense from a true, natural restoration concept

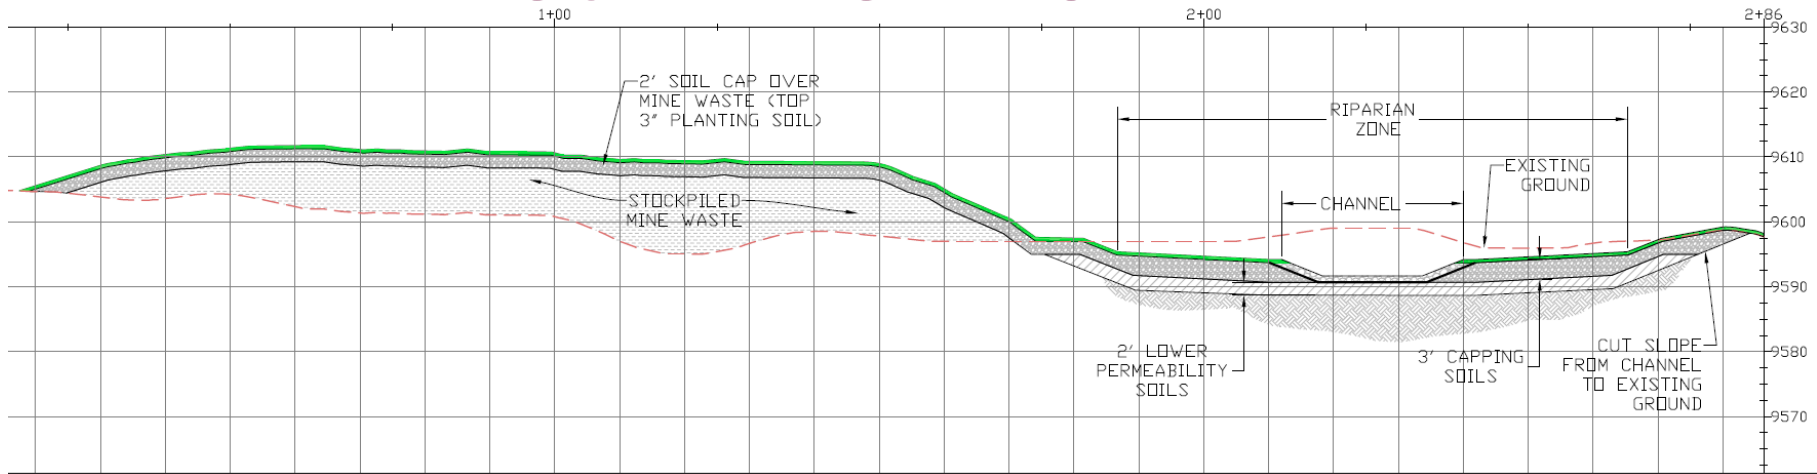
# TAILINGS MITIGATION PLAN

Reduced sinuosity and changed bedform to plane-bed to reduce vertical scour

Raised stream profile to minimize hydrologic connection between stream and waste

Armored stream to minimize lateral and vertical migration

Consolidated and capped waste

Changed construction sequencing to keep mine waste dry during construction

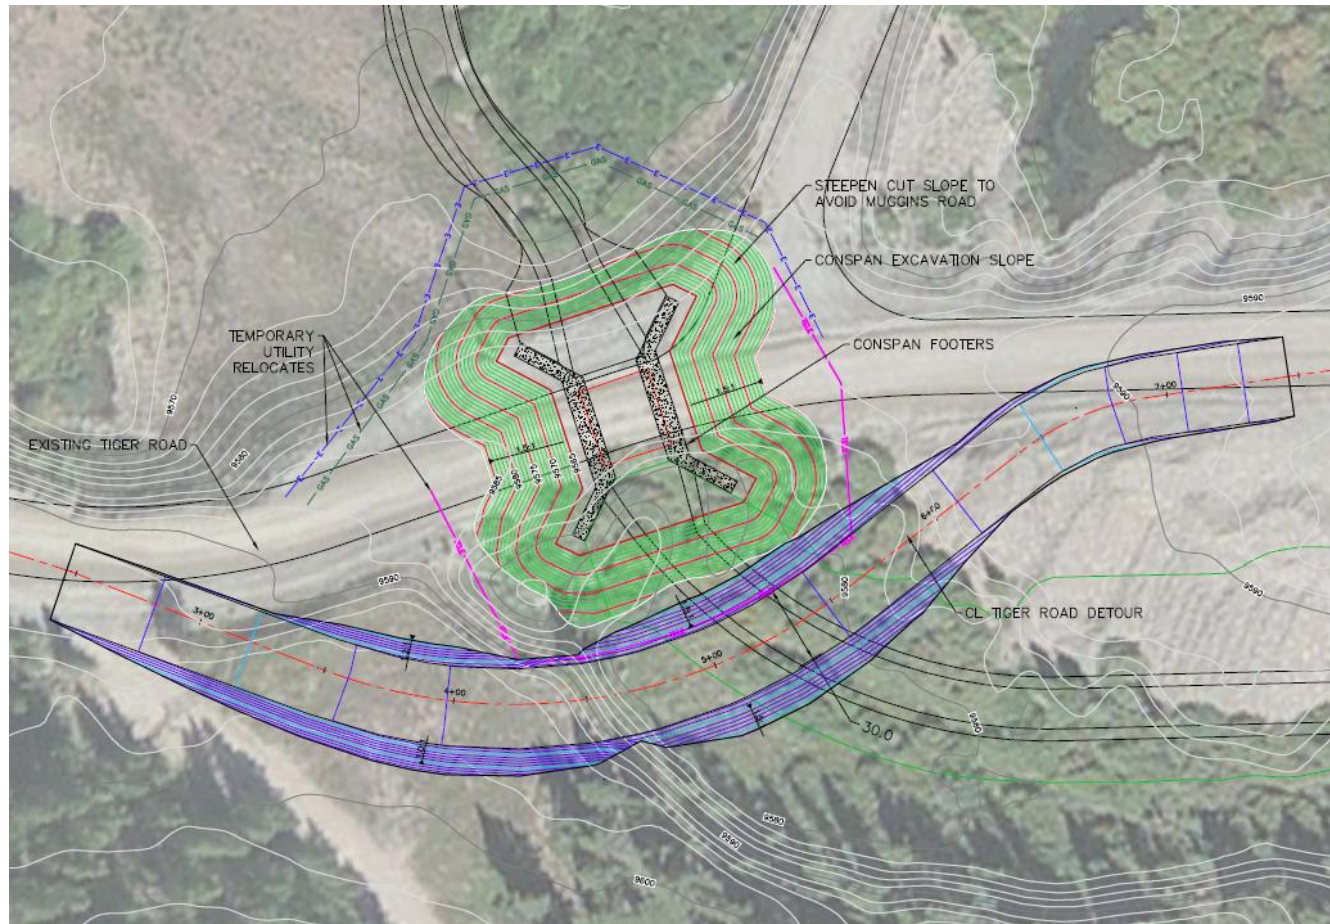
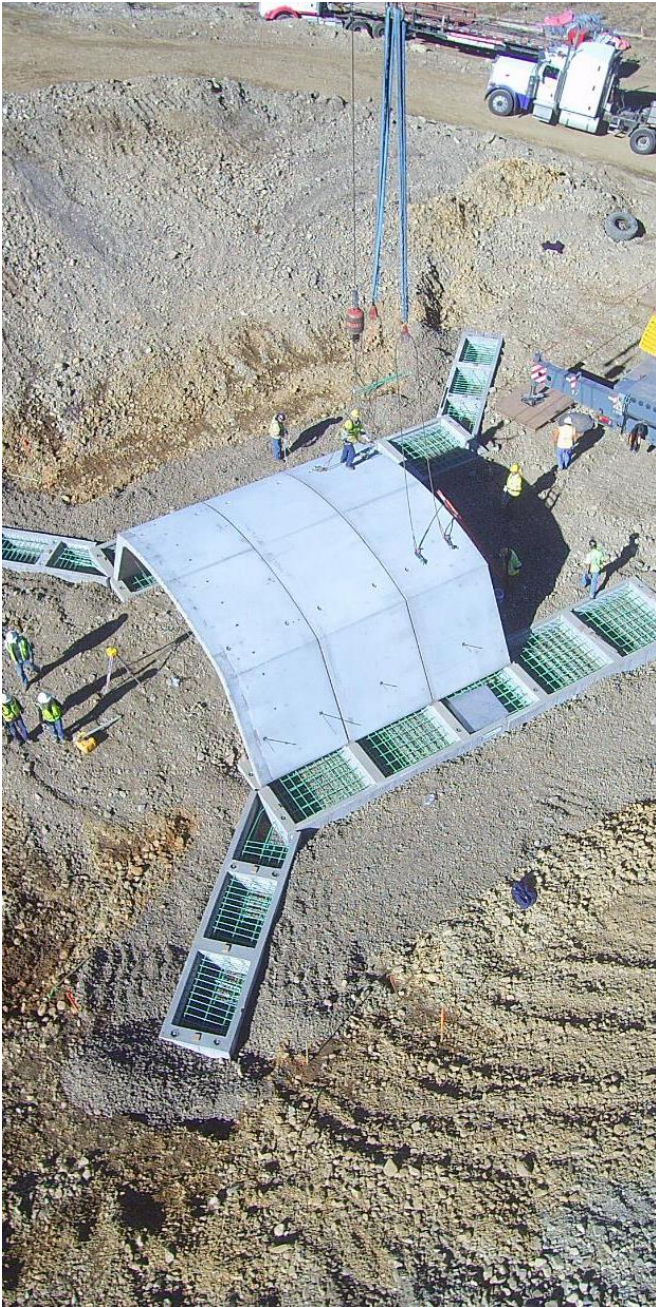
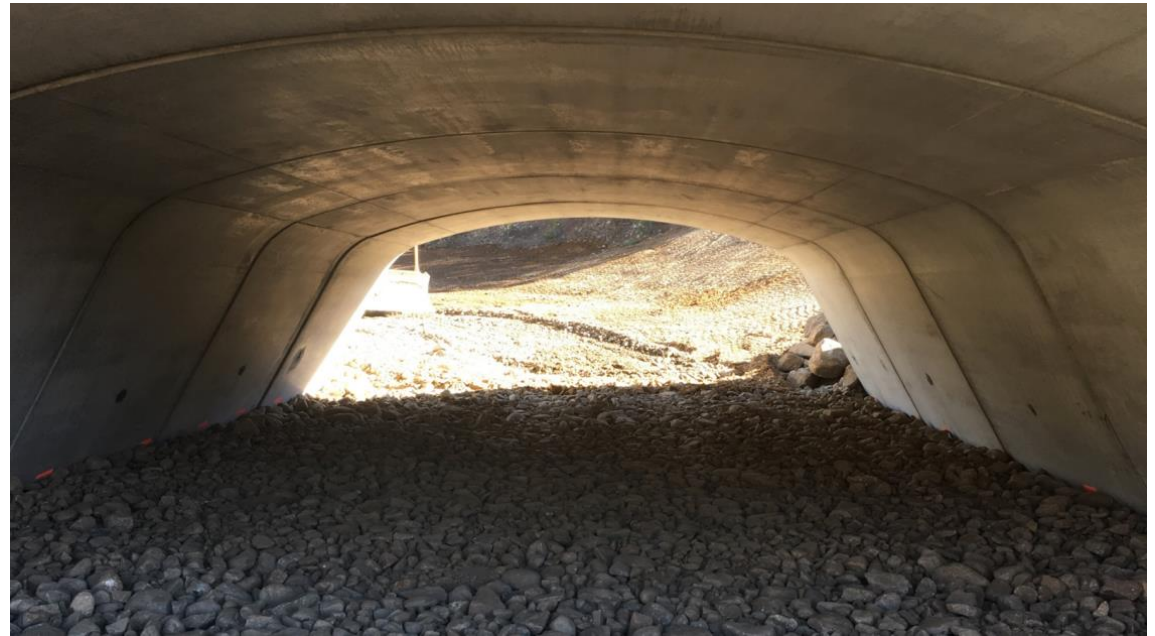
# BRIDGE CONSTRUCTION

DESIGNED TO REDUCE NUMBER OF CROSSINGS, REMOVE EXISTING FISH BARRIER and ALLOW AQUATIC ORGANISM PASSAGE

Natural bottom promotes  
aquatic organism passage
