Harvesting Burn Scar Material for Nature-Based Bank Protection

Barr Farm, located in Pueblo County, covers a one mile reach of Fountain Creek. The project scope included a combination of stream restoration and post-fire forest management.

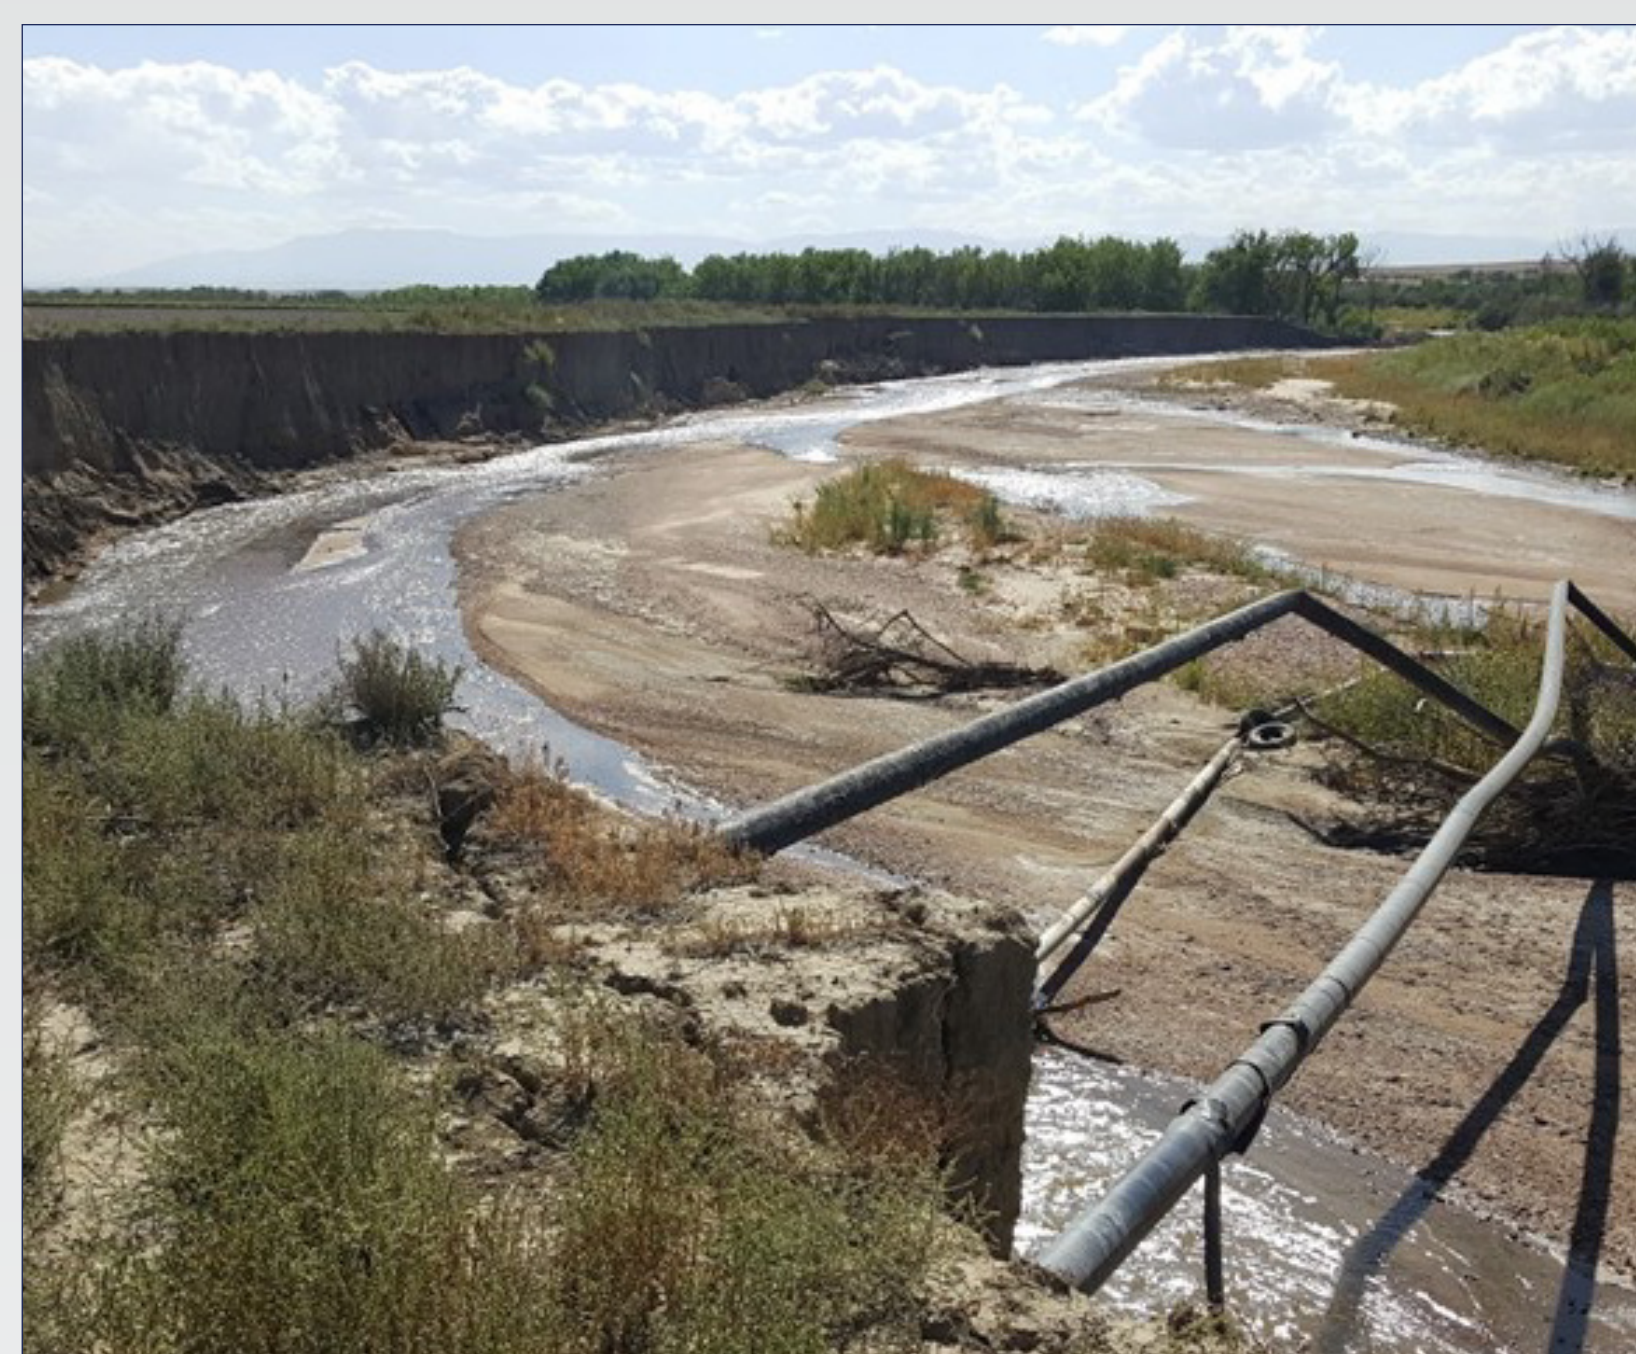
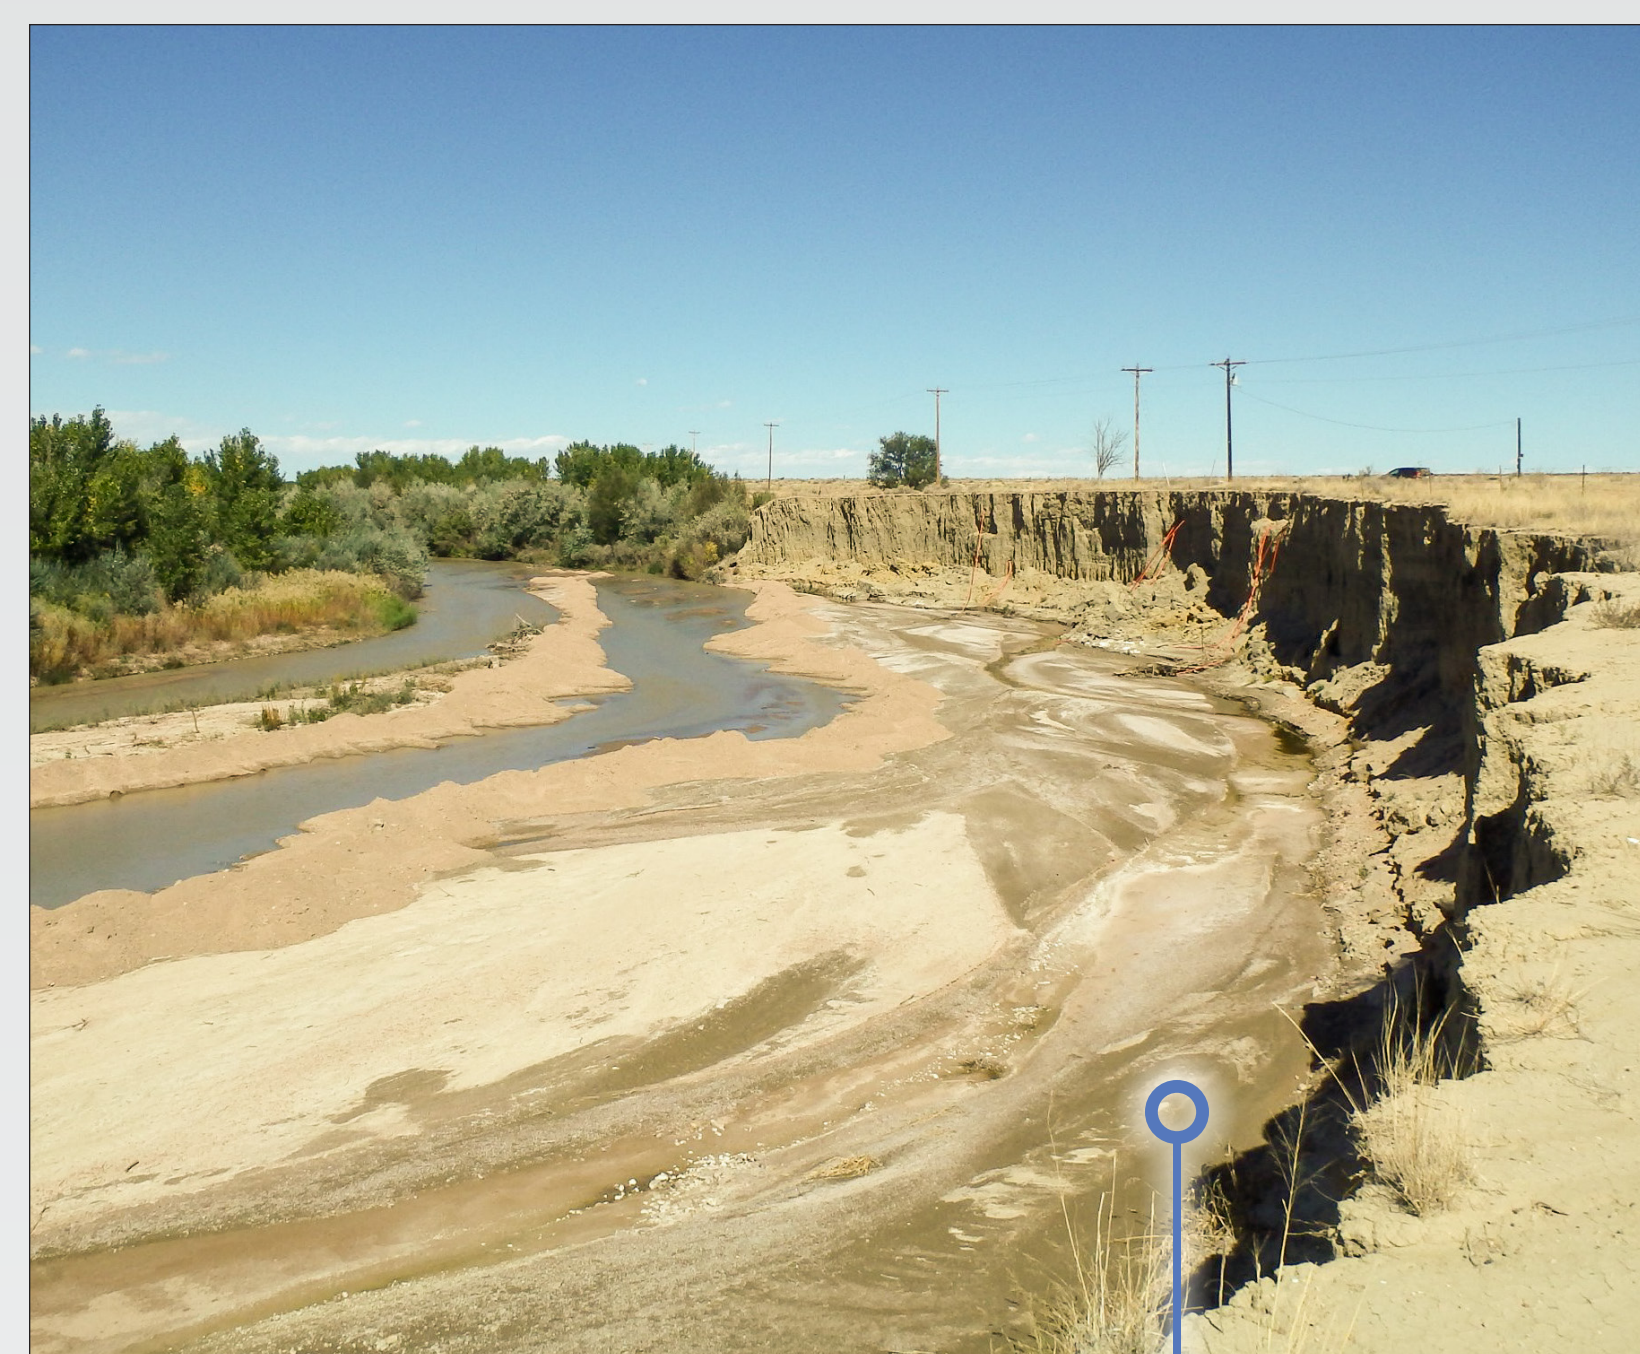
Pre-project conditions

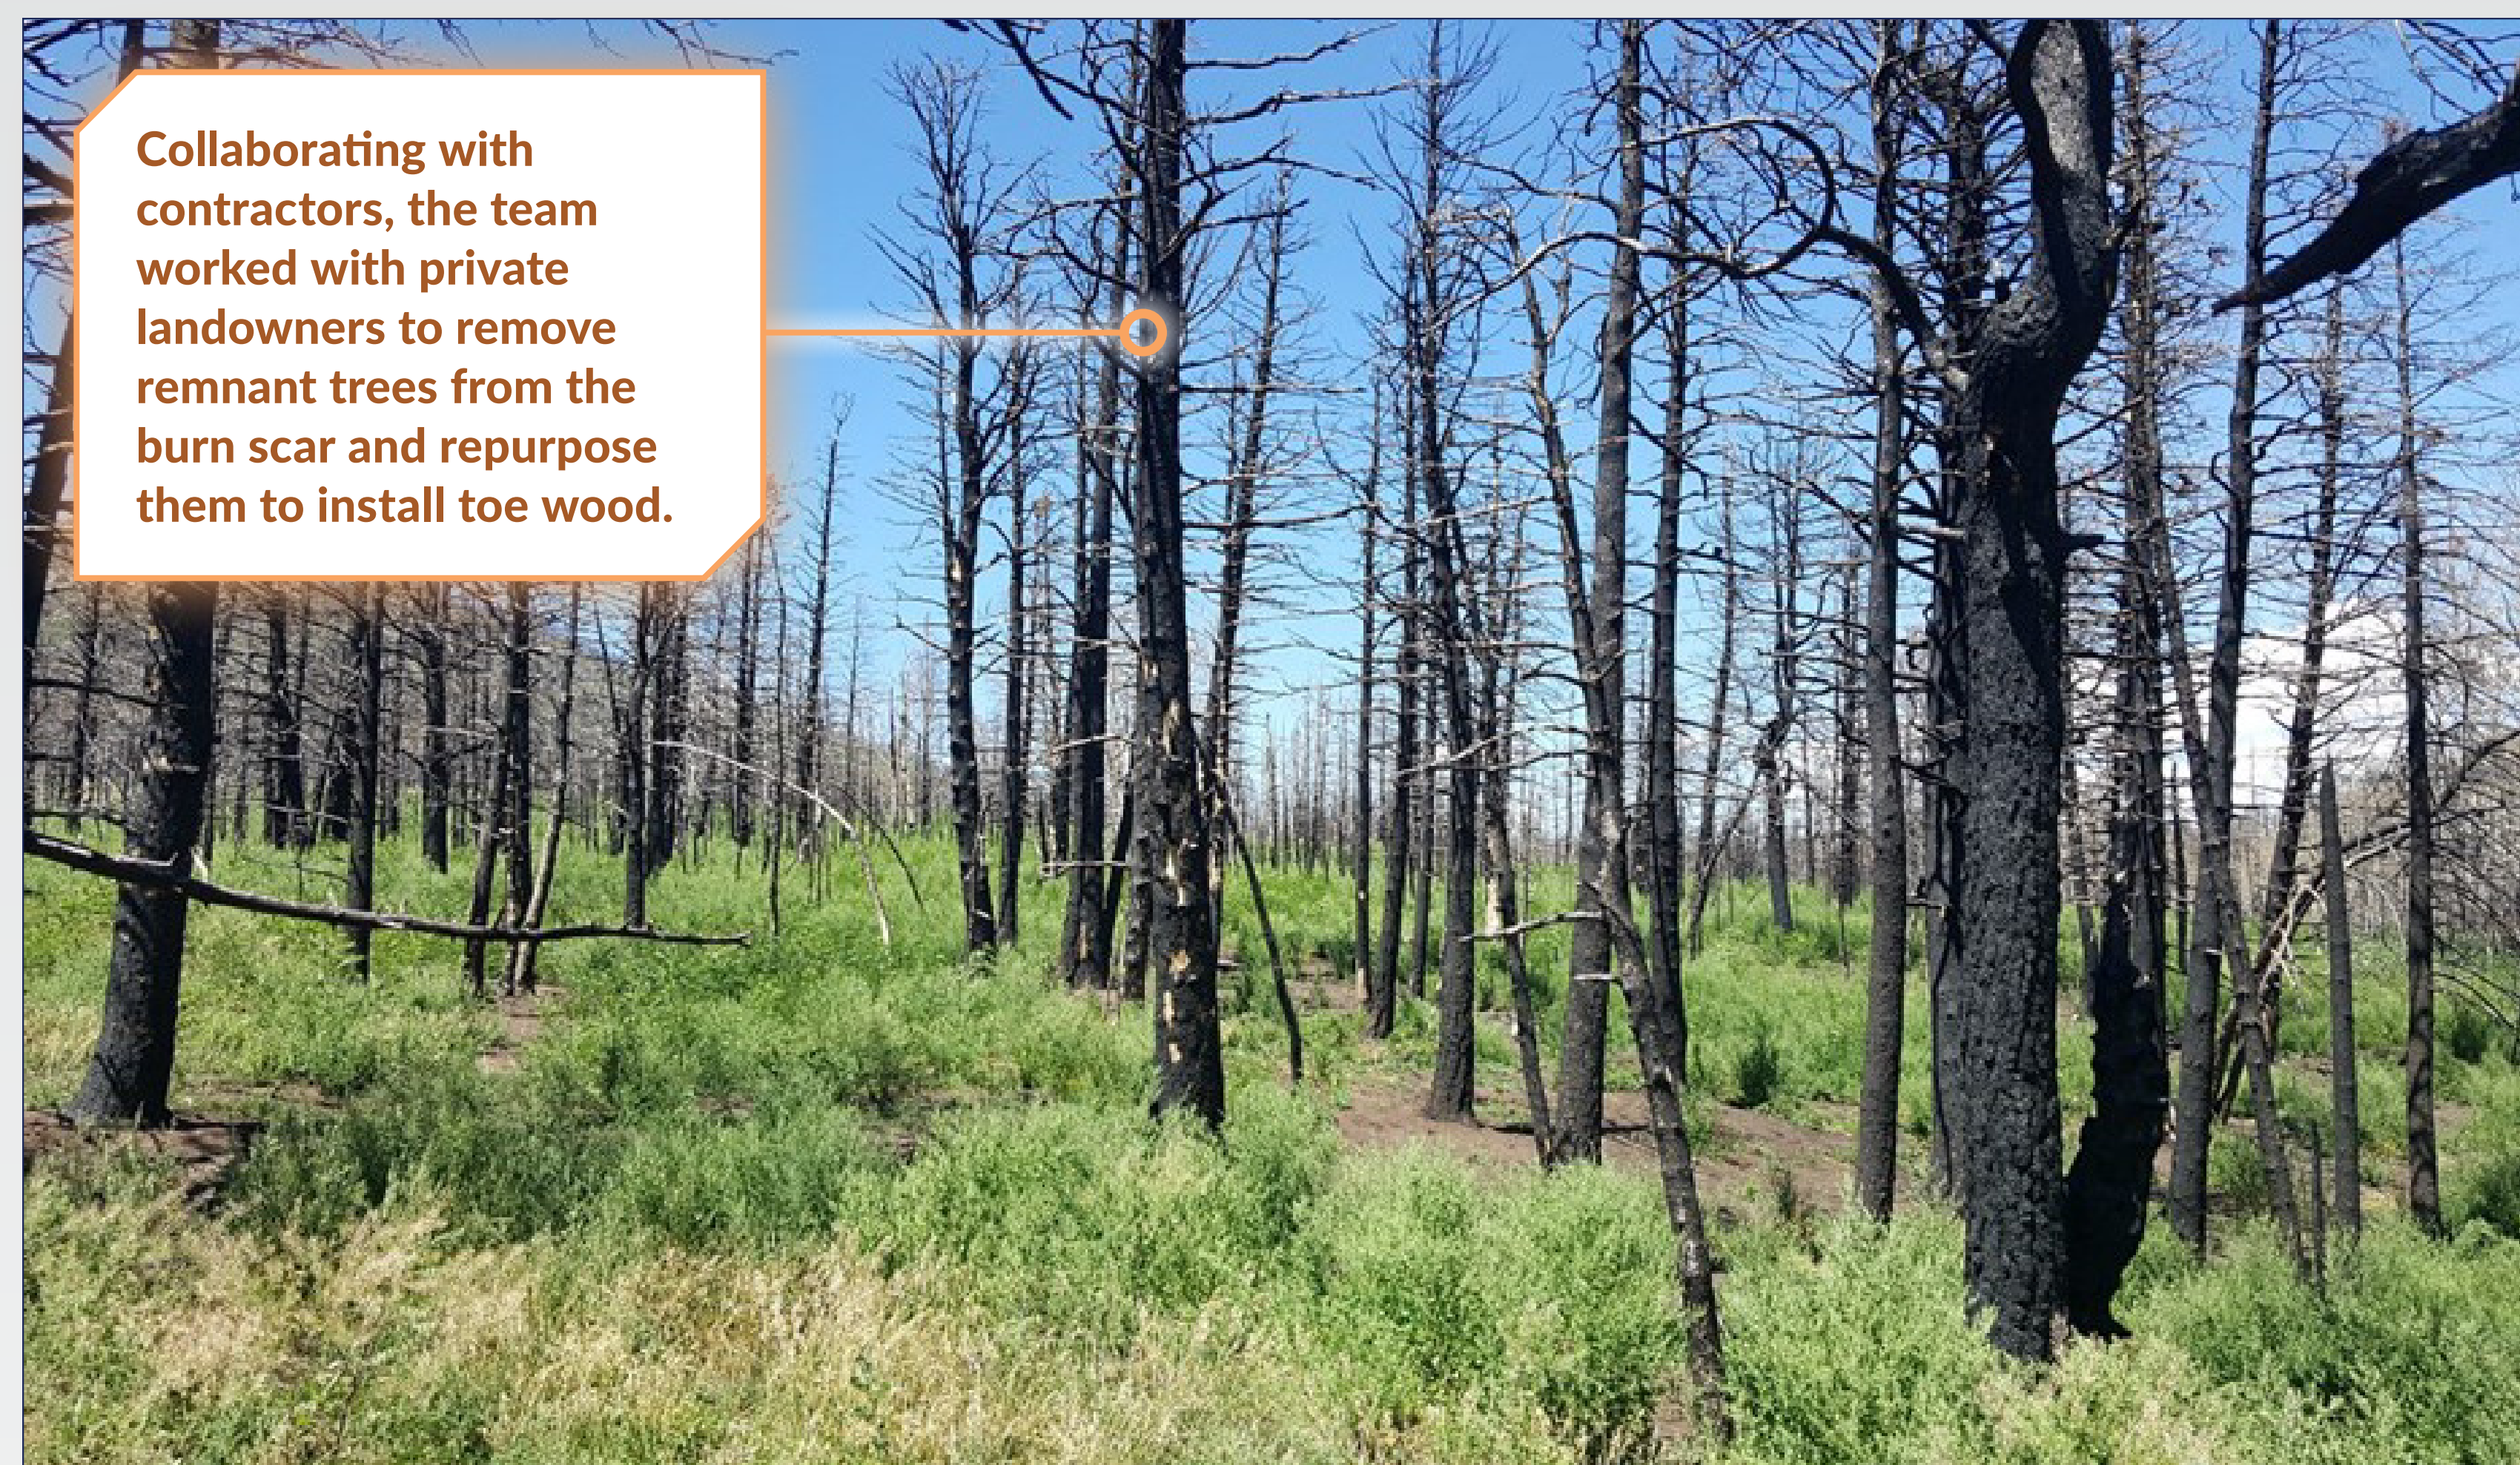
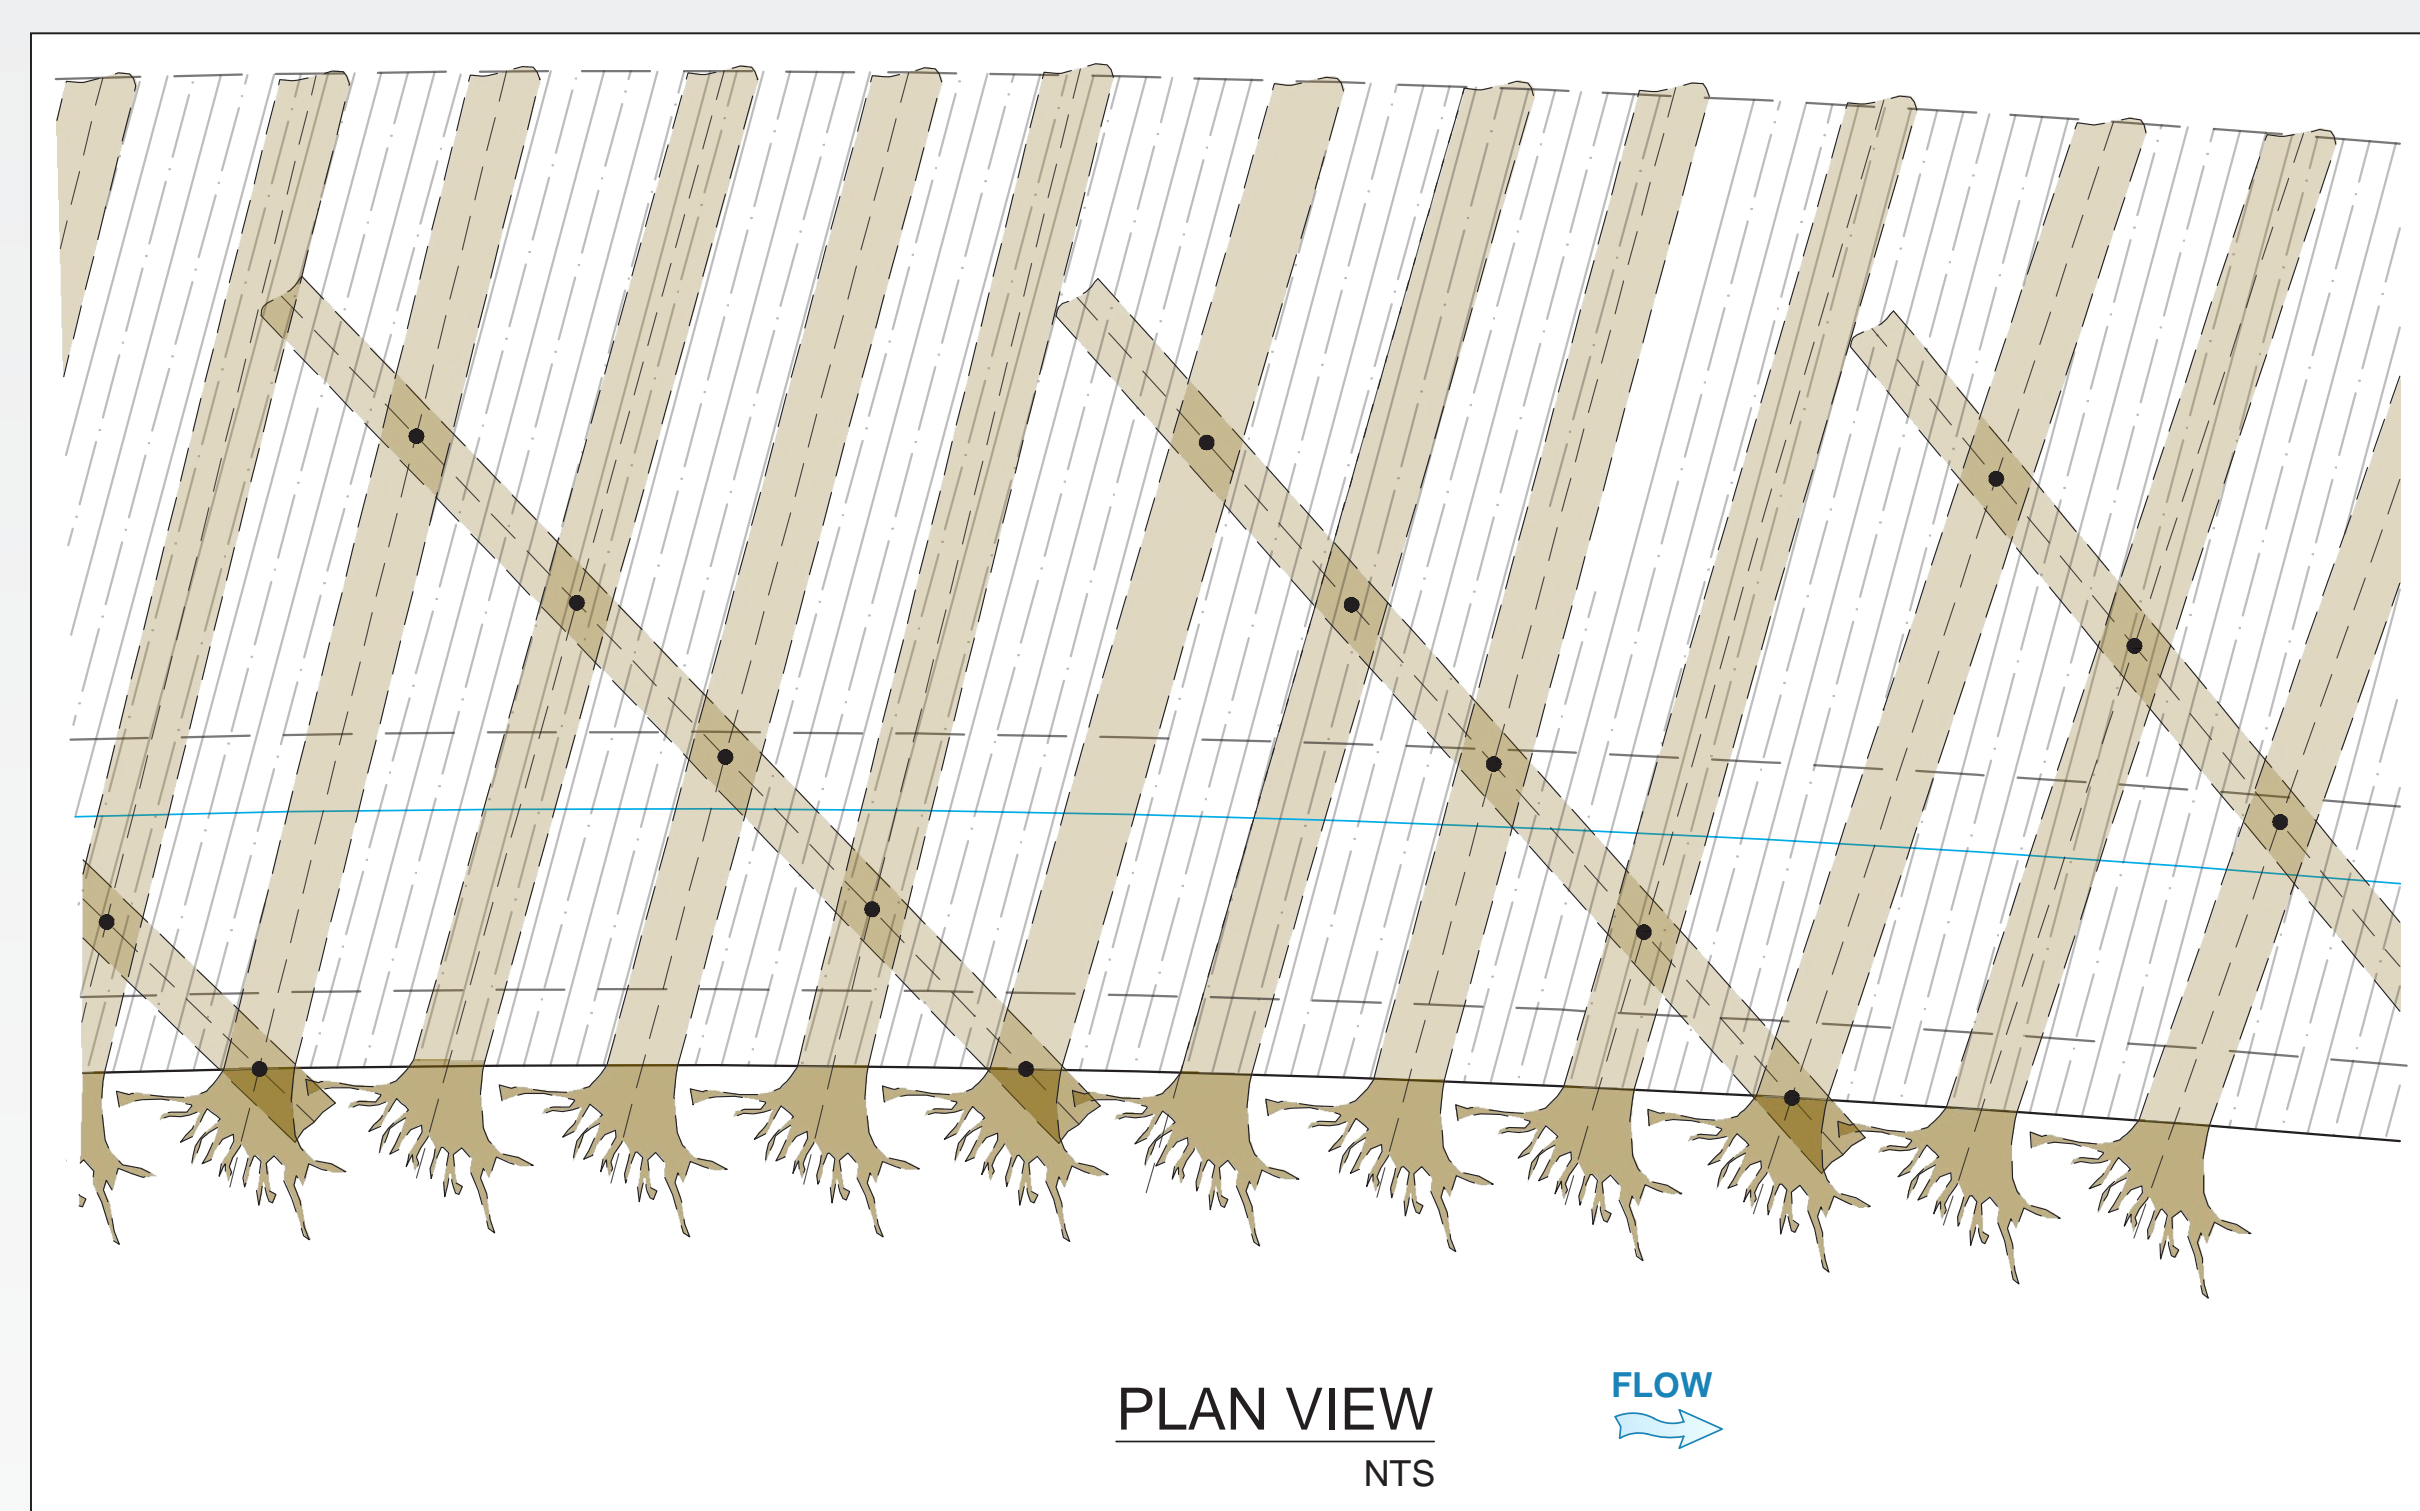
To reduce cost, the team developed a solution to utilize logs and materials from the 2018 Spring Creek Fire burn scar.
