Stephens Park Stream Bank Restoration Project

Colorado Water Conservation Board – Healthy Rivers Fund Grant Final Report

DRAFT - April 1, 2012

STEPHEN'S PARK BANK STABILIZATION TOWN OF VAIL, CO JULY, 2010

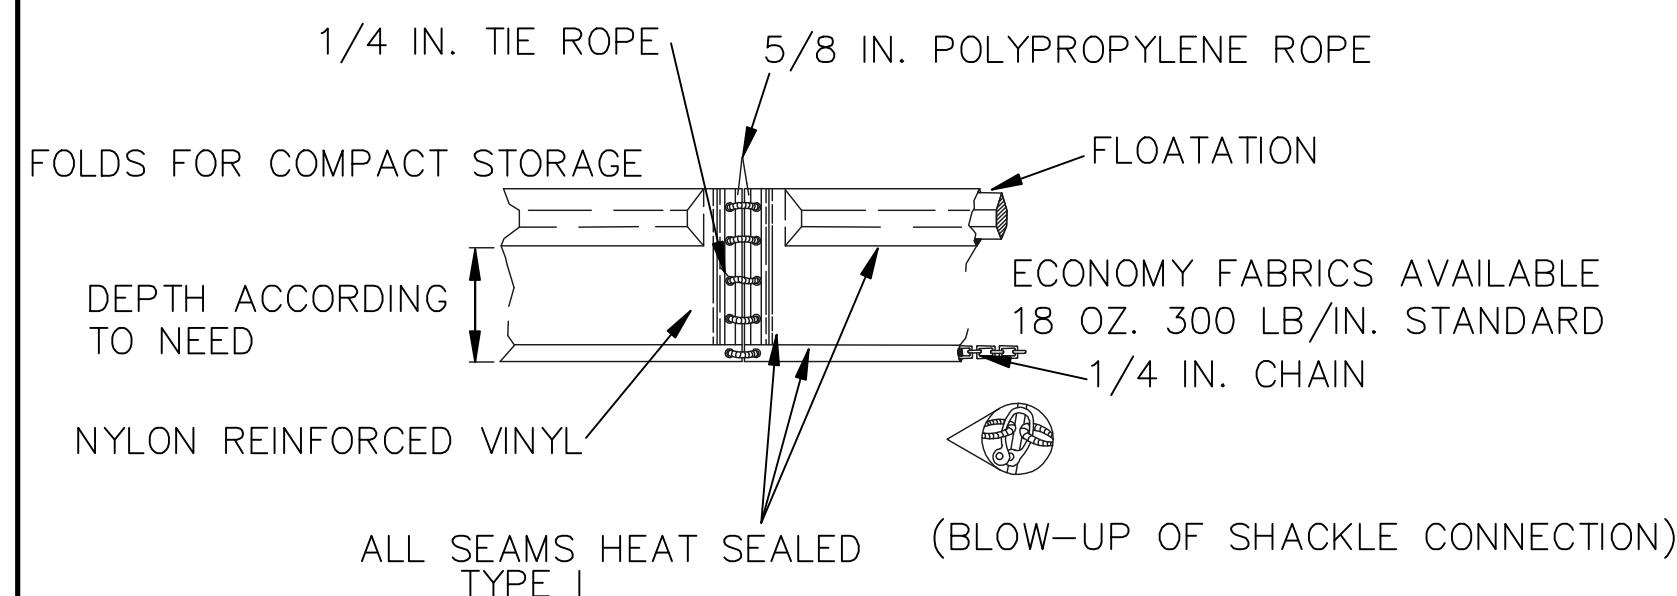
3
D1

TURBIDITY CURTAIN (TYPICAL)

TYPICAL LAYOUTS STREAMS, PONDS, AND LAKES (PROTECTED AND NON-TIDAL)

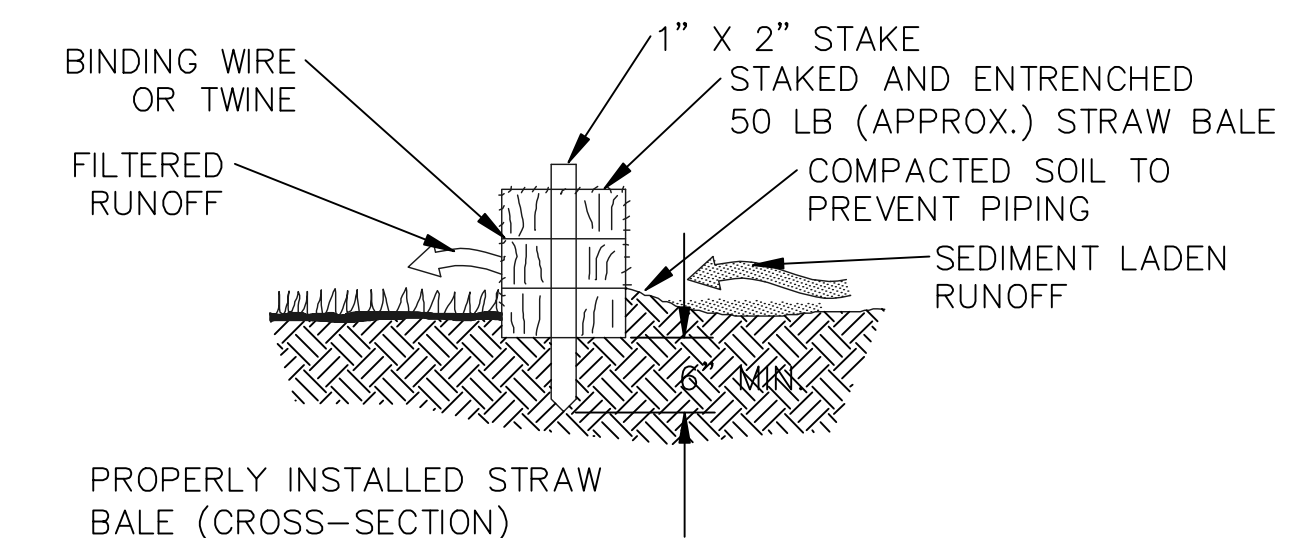
5
D1

STRAW BALE (TYPICAL)

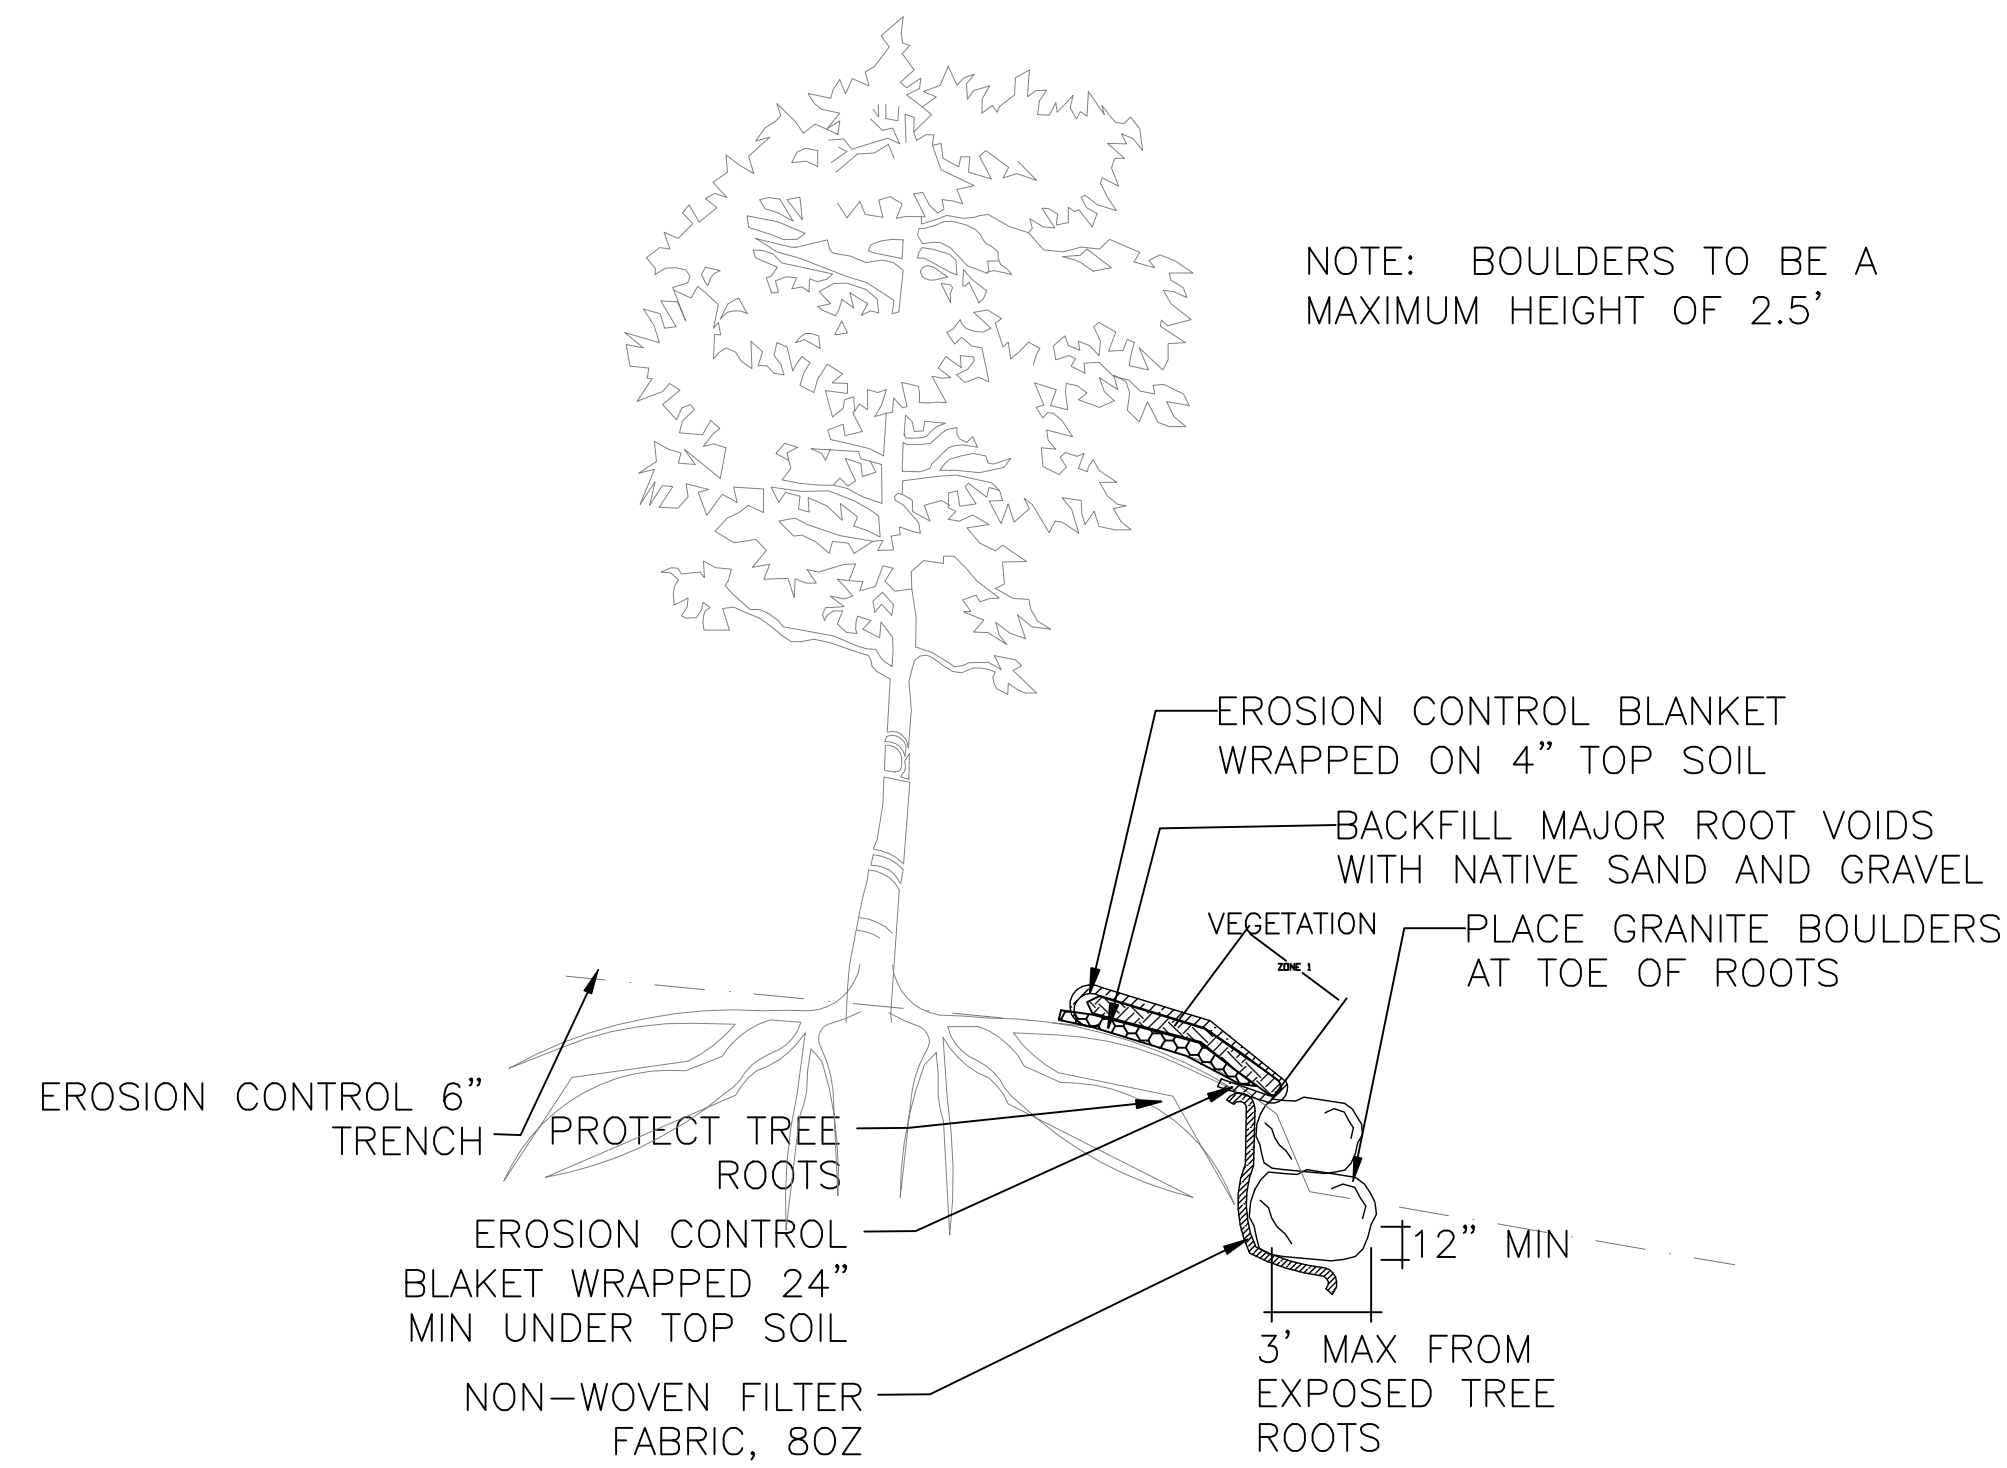
3 D2 EXPOSED TREE ROOT BANK STABILIZATION
SCALE: NTS

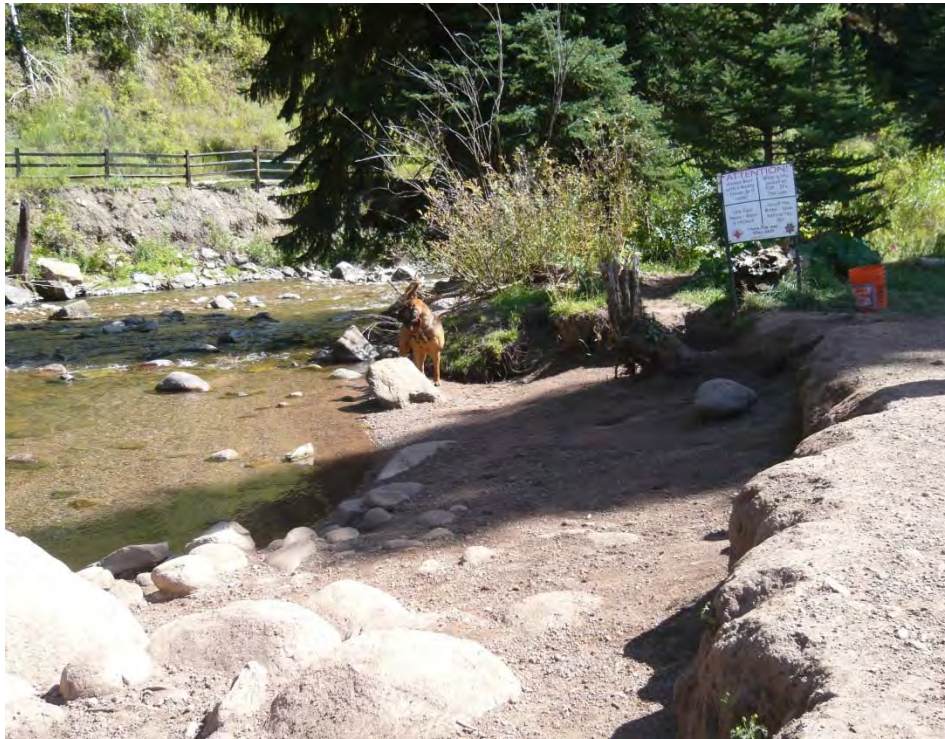
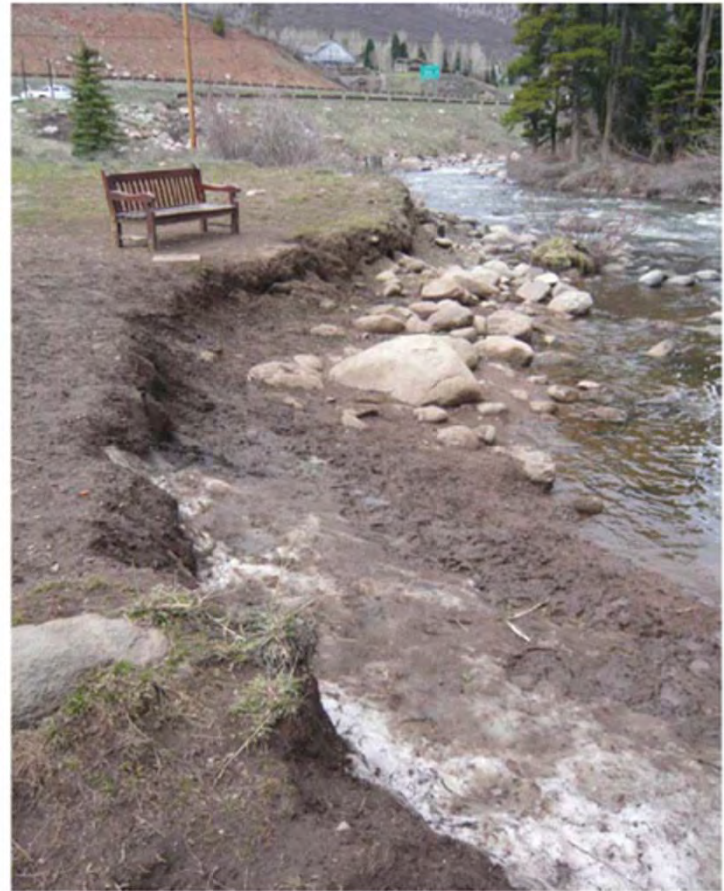
Stephens Park - Before

Eroded bank, sediment building, no vegetation
